Pitot-Tube Technology Helps Maintain Proper Airflow in Fitness Facility

Hot-wire anemometers succumbed to lint contamination

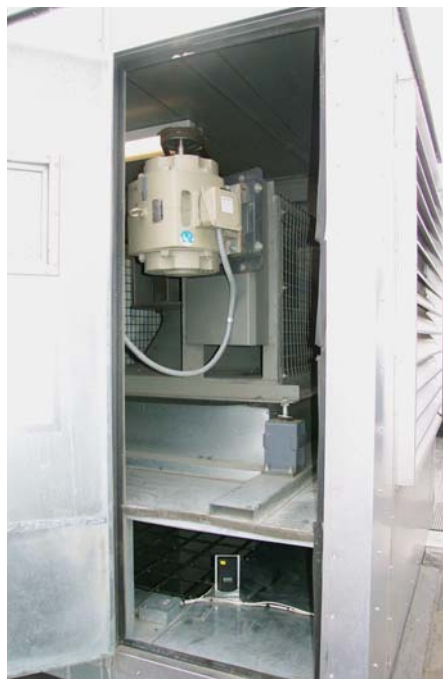
Access to the airflow sensor was limited.

“Every three months, we had to send someone in to clean lint off the hot wire,” Stein said. “The space is very tight, and the technician had to lie on the grate to reach the sensor. It was a difficult task, and nobody liked doing it.”

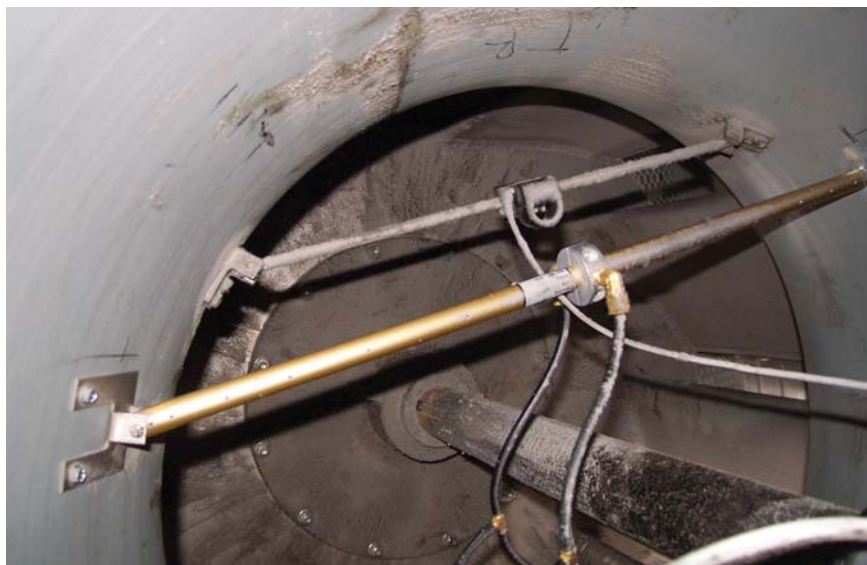
A Pitot-tube sensor (foreground) and a thermal-dispersion device (background).

“Rich came to us with the idea of putting a Paragon airflow-measurement device that uses Pitot-tube technology,” Blackburn said. “We thought it was a possible solution since the Paragon device doesn’t rely on a hot wire.”

Named for its inventor, French engineer Henri Pitot, a basic Pitot tube points directly into an air stream. With air already in the

tube, pressure can be measured as the moving air is brought to rest. Bernoulli’s equation is used to determine the dynamic pressure of airflow. Accuracy typically is 2 percent.

According to Stein: *“The hot-wire*

anemometer performed exactly as it had before, collecting a coating of lint with our equipment, showing a linear deg-

radation as the coating got thicker. After cleaning, the performance would bounce back up and then begin to degrade again. The Pitot-tube device didn’t degrade at all, and it required no cleaning. It’s still performing up to spec, and we haven’t had to clean it. Naturally, we don’t use the

hot-wire anemometer anymore.”
